CORRIDOR DIAGNOSTIC STUDY OF THE NORTHERN AND CENTRAL CORRIDORS OF EAST AFRICA

ACTION PLAN

Volume 2: Technical Papers

F. Lake Transport

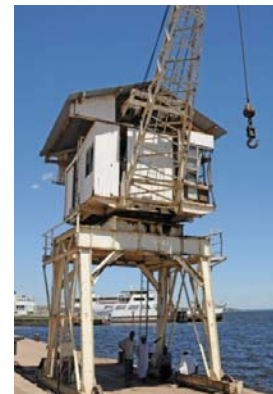
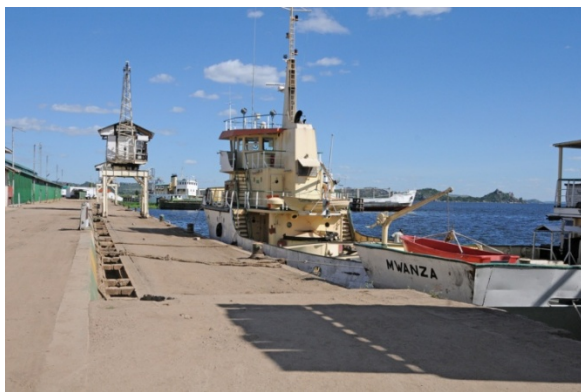
The main jetty is a pile structure approximately 265 m long overall of which 180 m are bi-level as in Kigoma. It was constructed on piles between 1919 and 1925. The lower level jetty is 6m wide. The upper level is approximately 1m higher than the lower one and is also 6m wide. The two are separated by a drainage culvert approximately a half a meter deep. The TPA is planning on putting a new cap on the lower apron to bring it even with the upper level. However, there is no available

information on the original design and the TPA must do an engineering feasibility study to determine if and how it can be done. The TPA is also planning to remove the transit sheds on the wharf and build a container yard in their place and incorporate the large nearly unused rail yard behind the warehouses as well.

Mwanza also needs to rehabilitate or replace its bi-level quay that was also built in the 1920's probably using the same pile system as found in Kigoma. Again an engineering survey as proposed for Kigoma is required to determine what needs to be done. The port will also need a couple of new 10-15 ton shore cranes and several forklifts for handling its general cargo traffic. If the barge service is implemented the port will also need 3-5 yard tractors and a reach stacker. Finally, although Mwanza is the home to two large relatively modern dry docks, its machine and ship repair shops are inadequate for doing any major repairs. If it wants to develop this business the machine shops will need a major upgrade.

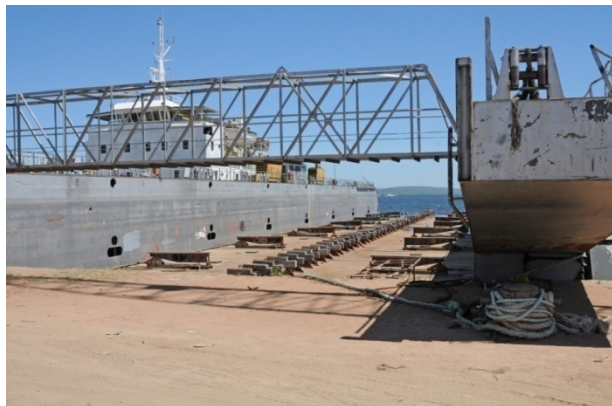
One of the positives in the port are the two relatively new dry docks that are fully functional. The large one is the newest and is 100 m X 24 m with a lifting capacity of 2,100 tons. The smaller one is 70 m X 13 m and has a lifting capacity of 860 tons. These dry docks are supported by a small machine shop that has significant arc welding capability backed up by a large diesel generator. The remainder shops are poorly equipped and would need a significant upgrade to be

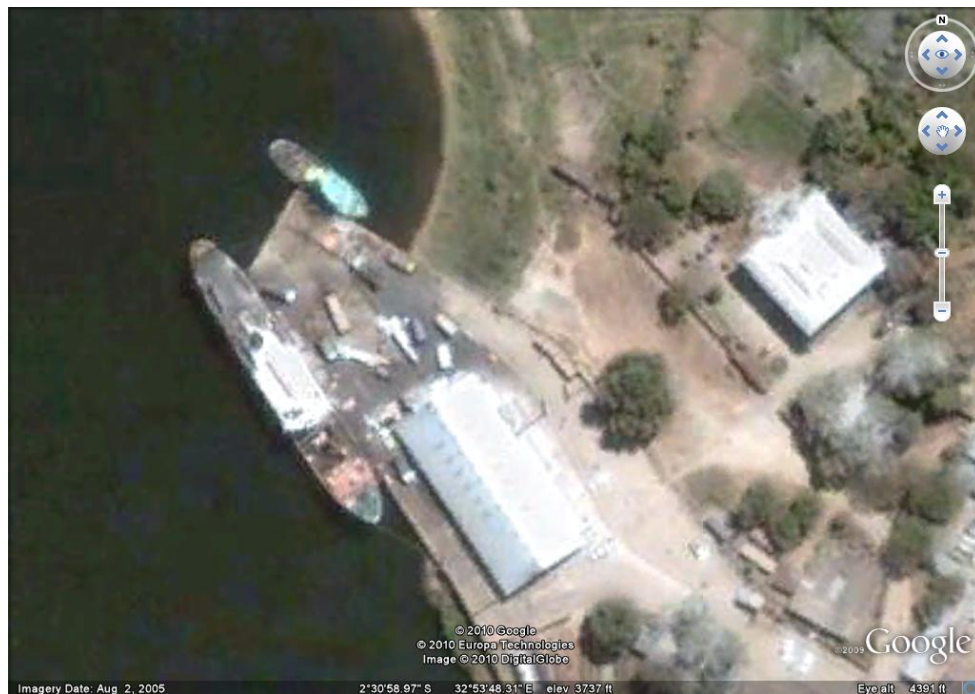
Mwanza operates a passenger terminal several miles away from the cargo terminal called South Port. The main berth is approximately 95 m long of which 70 m is deep enough to accommodate the largest passenger vessel on the lake, the Victoria. There is also a second smaller berth that is approximately 30 m long. Both berths are restricted at the shore side ends by shallow depths causing the vessels to “hang over” beyond the end of the pier. There is a 46 m X 22 m transit shed adjacent to the main quay that serves as a short term storage shed for general cargo. The site also includes a two story administration building that is 24 m X 24 m.

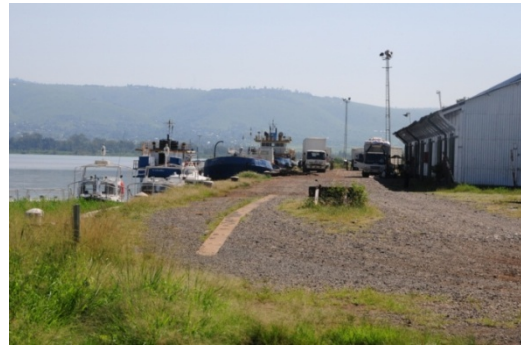
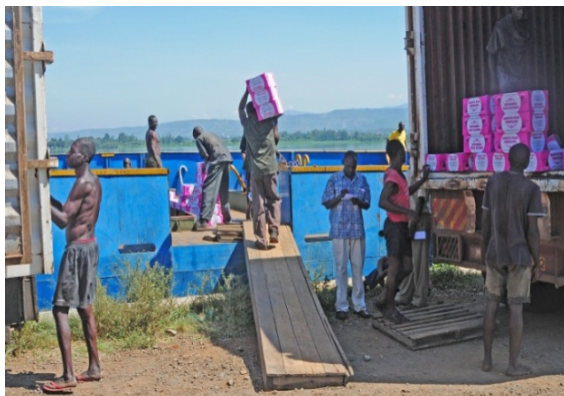
The port is owned and operated by the Kenya Rail Road (KRR) and consist of approximately 12 acres inside the KRR fence and 30 acres surrounding the port that is owned by the RR. The jetty is 900m long of which approximately 500m is operable due to the growth of thick hippo grass and siltation. The jetty is a pile supported structure built in the 1920's with an 18 inch thick facing wall that extends from the water level to the top of the jetty which was added latter when the level of the lake rose. Hard packed gravel/sand was filled behind the wall on top of the original apron to raise the level of the jetty. There is no information regarding the baring capacity of the wharf. To extend the operational length of the jetty, the port needs to carry out some light maintenance dredging at either end to remove the hippo grass and built up silt.

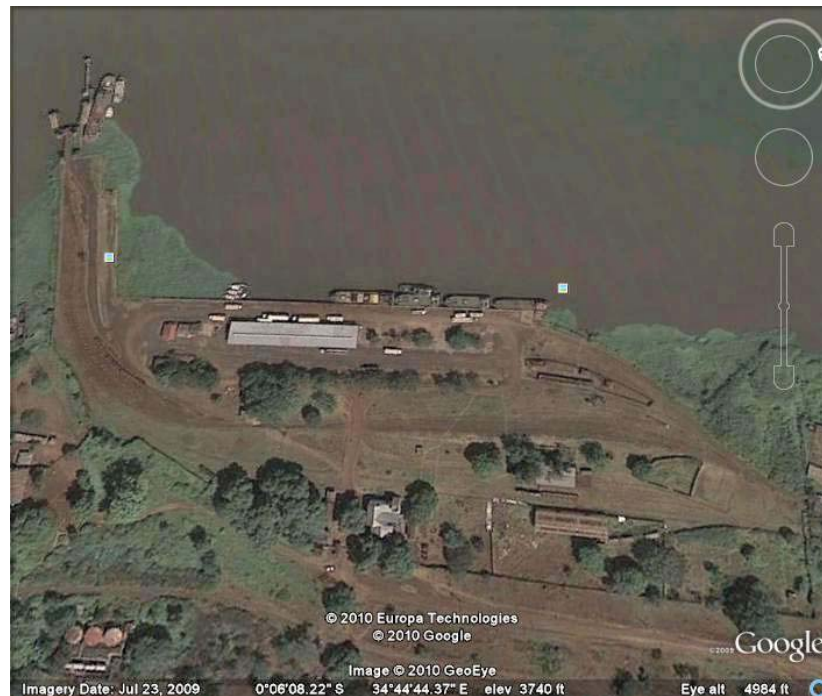
The port includes a docking facility for the only other operable wagon ferry on the lake the Uhuru. Built in 1963 in the adjacent dry dock, it has recently been renovated and is ready to go. It, however, is waiting for certification and insurance to be put back into operation but has not been able to get an affordable policy. It is the same size and capacity as the wagon ferry in Mwanza. The original rail connections to the dock were built in 1929.

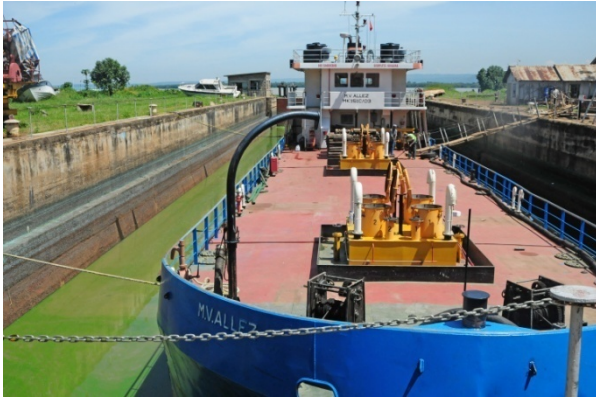
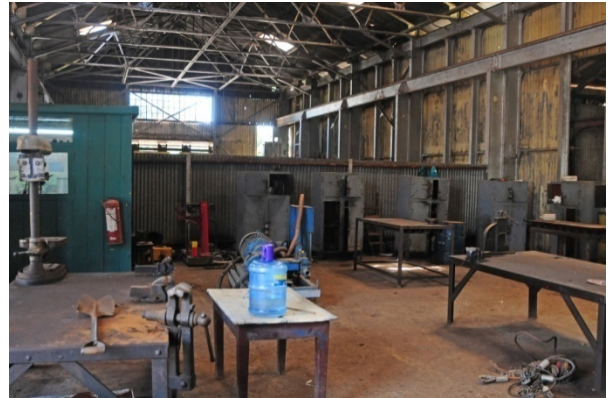
The facility includes two slip ways one of which lies derelict, fully grown over and unusable. The second one is gradually being renovated by the KRR for future use. It can accommodate vessels up to 800 tons. The facilities include:

- A large machine shop with aged but operating equipment
- A fabrication shop also with aged but operating equipment
- Carpenter shop
- Wrench house for pulling the boats onto the slip way

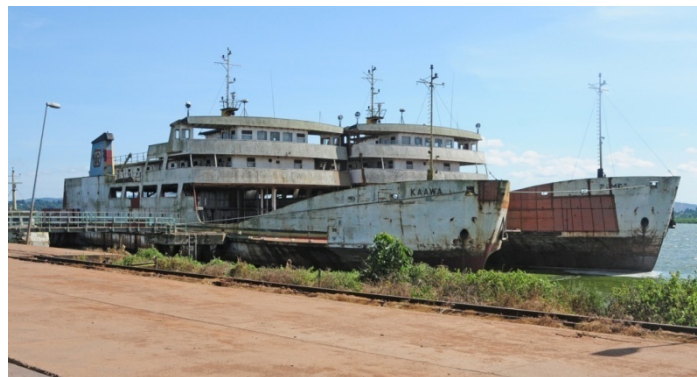
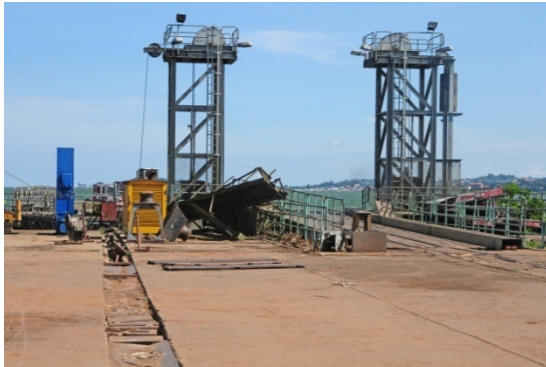
Port Bell is comprised of one finger pier that is 100 m long and 45-50 m wide. It is fitted with a standard rail link for the wagon ferry service operating on the lake. It currently has one operating mobile crane. It includes one warehouse approximately 75 m X 20 m that is divided into offices, stores rooms, and warehouse space. The depth along is 8m at the wagon carrier link and is one of the deepest ports on the lake.

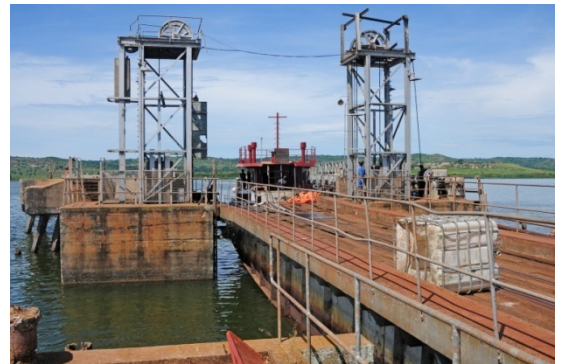
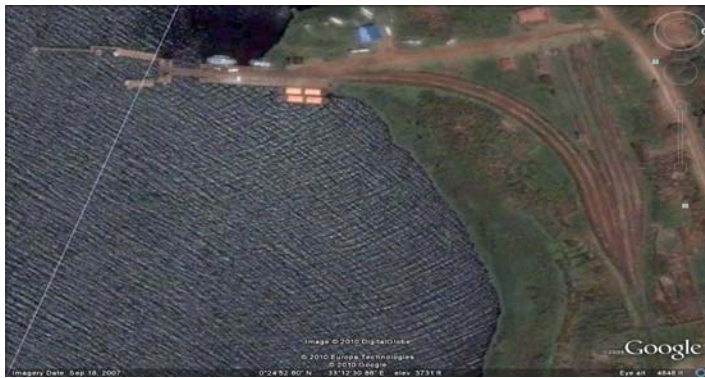
Jinja was the most undeveloped and decayed of the ports that were visited. It is a finger pier measuring 50 m X 15 m with a standard rail link and dolphin mooring system attached to the end. It has not been in use since 2004 and consequently is in very poor condition with most of the planking and fendering systems decayed beyond use. When the wagon ferries were in operation it was used primarily as a relief port for Port Bell when it was congested. It also has a draft of 8 m and can handle boats up to 500 GRT.

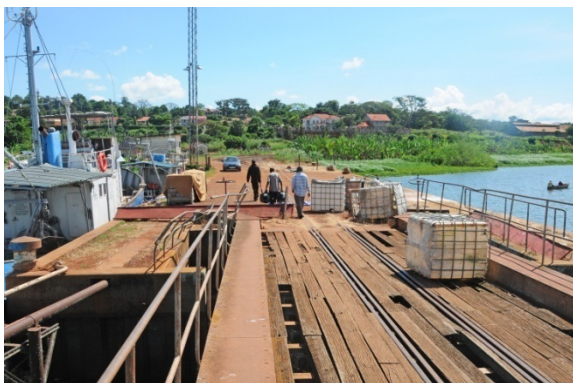
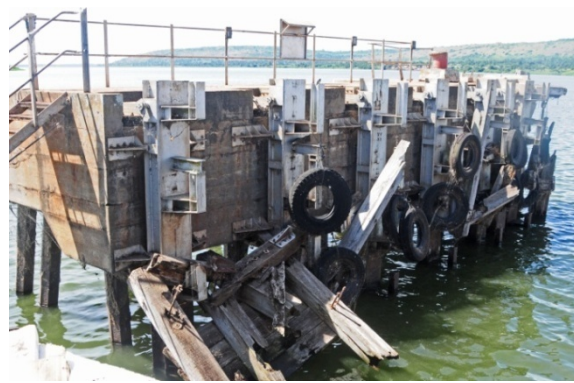
In addition to the decayed state of the pier the rail line to the local ICD (3 km away) is 3 percent and is very dangerous to use with the poorly maintained equipment. There is a small rail yard near the entrance of the pier where wagons are marshaled. The second major problem is the dirt road running down to the port. It is steeply graded, heavily crevassed, and in several places the difference in the level of the left and right wheels is approximately 12-15 inches making it very dangerous for high trucks to drive down to the pier. The long term development potential of this port is not good.

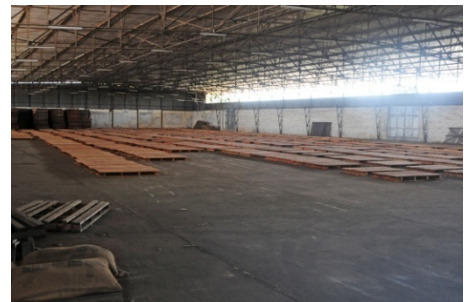
The port has four warehouses each 2,000 square meters, two of which are used for coffee or other bagged goods; one is used for general cargo and one for bagged cement. They have two smaller secured warehouses of 800 square meters in the back of the terminal for storing higher value cargo. The operation is quite modern. It employs terminal pallets for all of its cargo handling activities. The cargo generally comes in bags and is free loaded in the hold. The terminal pallets are loaded in the hold by stevedores and then transferred directly to the apron. These are then picked up and transported to the warehouse by forklifts. Truck loading is done at the back of the apron and behind the warehouses. The loaded pallets are placed on the back of the trucks by forklifts and stevedores remove the bags and free stow them on the trailer. EPD maintains a computerized inventory control systems for managing the operations in the warehouses. This is the only modern general cargo operation that was observed in the ports that were visited.

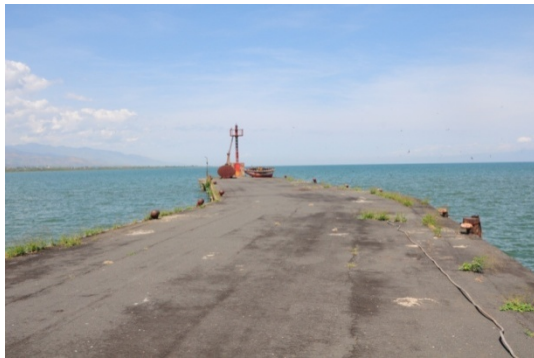
The passenger ship berth is located at the end of a long pier at the entrance to the port. It is well constructed with relatively new barrel fenders and with an apron that is approximately 10 m wide. It is physically located outside the port perimeter and has a separate terminal building for processing passengers. This building is an old warehouse that needs to be rehabilitated to properly handle passengers. However, the only operating passenger vessel on the lake is the 97 years old Liembra which sails only twice a month. Consequently, the terminal is little used.

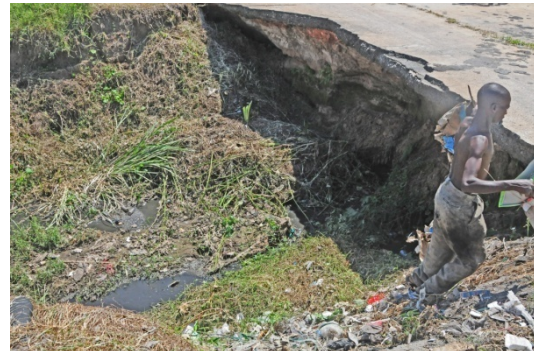
There is a sewer outlet that runs under the end coffee warehouse that is undercutting the wharf in front of it causing it to collapse as shown in the photo below. This sewer needs to be rerouted and the wharf needs to be rehabilitated. The port also has a problem siltation due to a small stream that runs along the outside of the oil jetty. They want to also reroute it to enter the lake on the south side of the oil tank farm.

The immediate need in Bujumbura is the rerouting of the sewer channel that is passing under one of the warehouse and causing part of the quay to crumble. There is also a need to expand the coverage of the pavement behind the quay that is proposed for the barge service. Finally although they are still working, the 60 years old shore cranes need to be replaced in the next five years because the parts to keep them operating are no longer available.

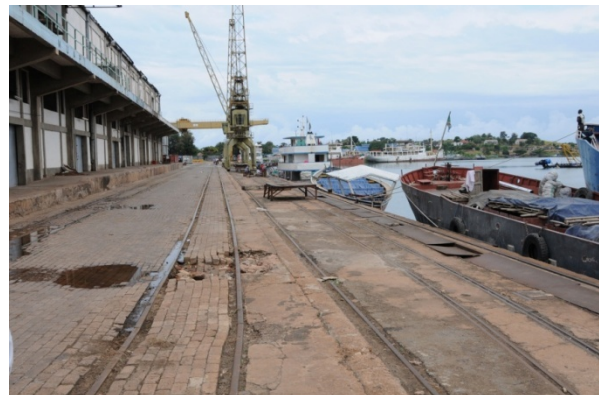
The existing jetty is a pile supported structure that was constructed in the 1920's and is in deteriorated condition. Apparently the top of the quay was at one time too low to the water and was being topped by waves. The port built a second level on to the wharf that was 0.85m higher than the original jetty resulting in a two tier wharf structure that was 205m long. The shore side apron is only 6m wide and supports three, 50 years old plus rail mounted shore cranes and a railroad track.

The upper level also supports a rail tract extending to the end of the container yard. The port wants to level the

jetty off to operate a new harbour crane. However, the condition of the piles (see photo) may require that whole structure need to be replaced.

Finally, as indicated above and illustrated in the associated photo, the by-level quay is in bad shape and will need significant rehabilitation if not replacement. Considering the condition of the piling shown here one cannot assume that one can simply add a new cap to the structure. The TPA needs to undertake a detailed feasibility and design analysis before attempting to add a new cap. This assessment is strongly recommended if the port intends to use the new mobile container crane that is expected in September.

Kigoma was expecting to receive a mobile container crane in September 2010. However, there is only a small section of the main quay where it can be safely operated on. The port needs to rehabilitate its main bi-level quay which was built in the 1920s using a pile system that has not been used since the 1930's. An engineering survey needs to be undertaken to determine if the quay must be rebuilt or if it can be rehabilitated and to subsequently develop the appropriated designs and cost estimates to do the job. In addition they will need to replace the antiquated shore cranes for two modern 10-15 ton rail mounted derrick cranes for handling general cargo. Finally, the dredging projects needs to be completed for both the cargo and passenger terminals. This work should be contracted to an experienced operator.

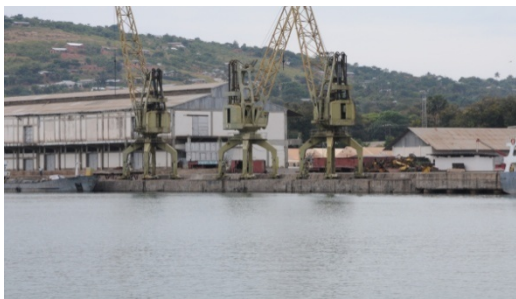
There are three shore cranes that are 57 years old and can only handle a maximum of 2.5-3 tons per pick when working. Only two are operational. The middle crane is not and is to be scrapped. Five of the ports eleven forklifts were out of service, three of five small mobile cranes and two of four yard tractors were also out of operation. Two of the working forklifts and the two working tractors were purchased in 2009 along with four

container trailers. Its other principal asset is a 105 m wide bridge crane capable of lifting 35 tons. However, the hydraulic spreader bar is under repair. The port is expecting a new mobile container handling crane in September.

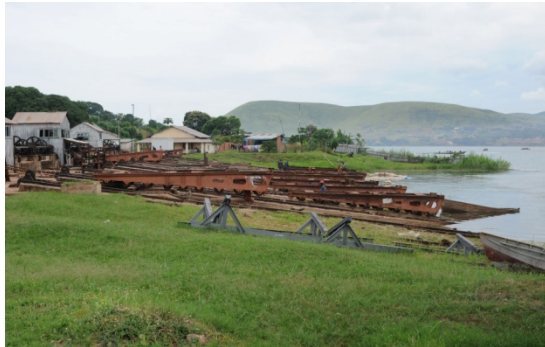
The port is equipped with a set of slip ways that are used for the repairing of vessels on the lake. It has been out of service for some time and is now being renovated and is expected to be put back into service by August. It is 80m long. Behind it are associated carpentry and machine shops used for repairing vessels. The machine is old and will require some upgrading before the yard can come into full production.

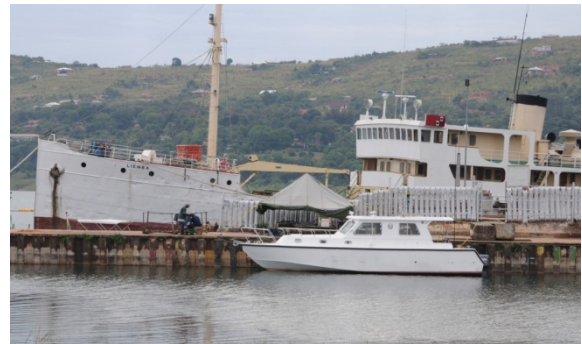
The Liemba is a passenger/cargo vessel that was built in 1913 and is the oldest commercially active vessel in the world. It has a capacity for 600 passengers and 200 tons of cargo and sails twice a month. Because of the situation the draft restrictions and the barge cargo must be discharged manually. This then requires the cargo to be lifted from the hold using the ship crane, and then hand carried it from the deck over the barge to a waiting wagon 50 to 70 meters away. This operation is handled by the TPA and not the terminal operator and consequently does not have forklifts available to assist in the operation.
